## Salmon Falls, Milltown Dam and Fishway

### **The Milltown Fishway**

### **Milltown fishway specs**

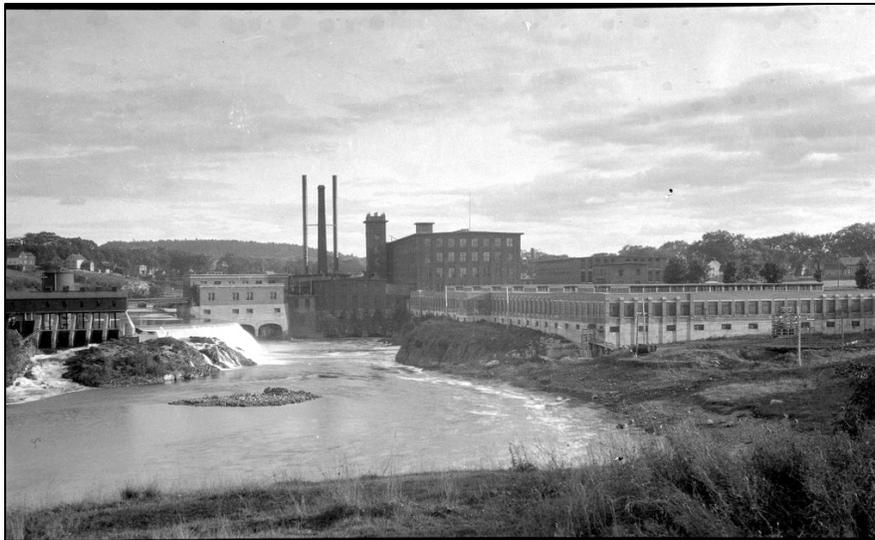
*Milltown dam, circa 1925.*

In the mid 1930's the dam was rebuilt with concrete. The cotton textile mill contributed significant chemical and biological wastes into the river. The cotton mill closed in the 1950's. Thereafter the cotton mill building was torn down and the dam portion remained.

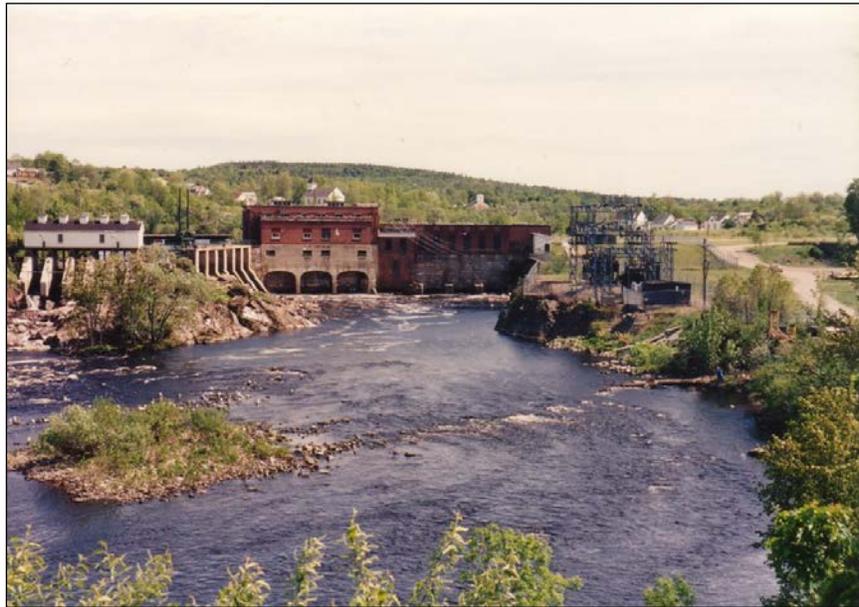
*Photo of the Power Dam at Milltown, NB.  
Photo taken in 2008, looking upstream*

After the cotton mill closed New Brunswick Power took over the dam and expanded the dam for electrical power generation.

The Milltown dam in place today is on top of Salmon Falls. It has 24 feet of head, and currently floods the upper part of the falls. Since this electrical generating facility is built in Canada the US Federal Energy Regulatory Commission (FERC) has no jurisdiction over this dam.

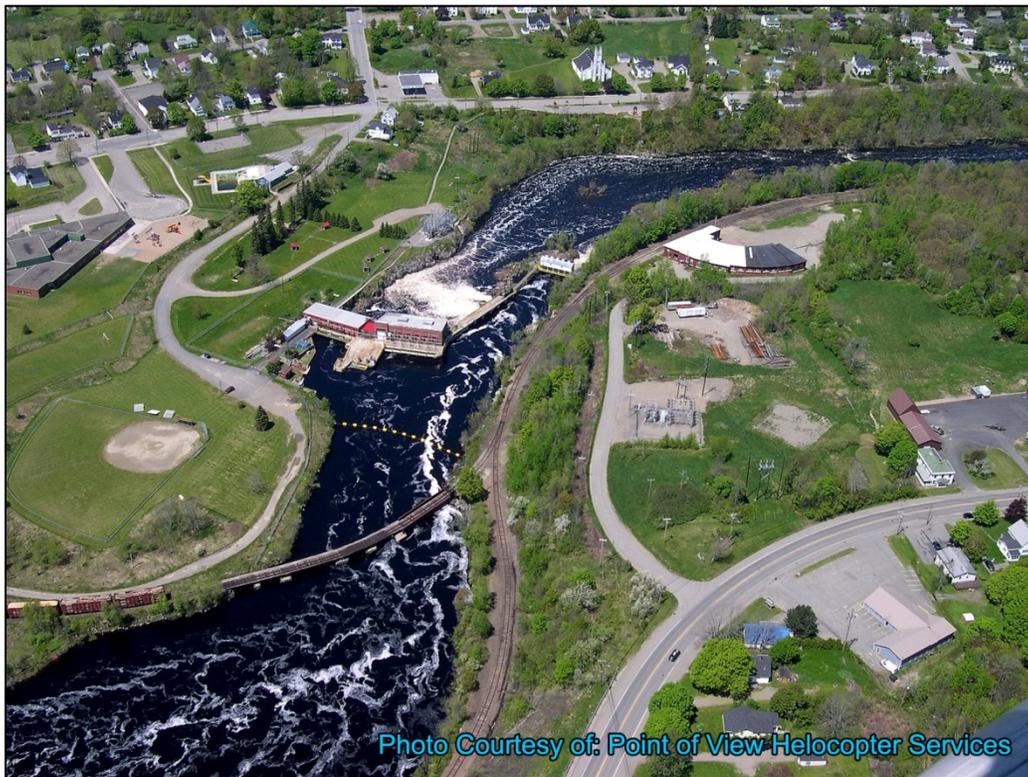
*Milltown Dam in 2016 (Canada on the left)*
